# ASSET ANALYSIS FOR RURAL WATER SUPPLY SYSTEMS

*Cate Zziwa Nimanya*  
*Country Director*  
*Water for People*

**PRESENTATION OF FINDINGS USING “DOWN THE HOLE BOREHOLE CAMERA” as a monitoring tool**

*By Samuel senfuma  
Hydrogeologist  
Ministry of water and environment*

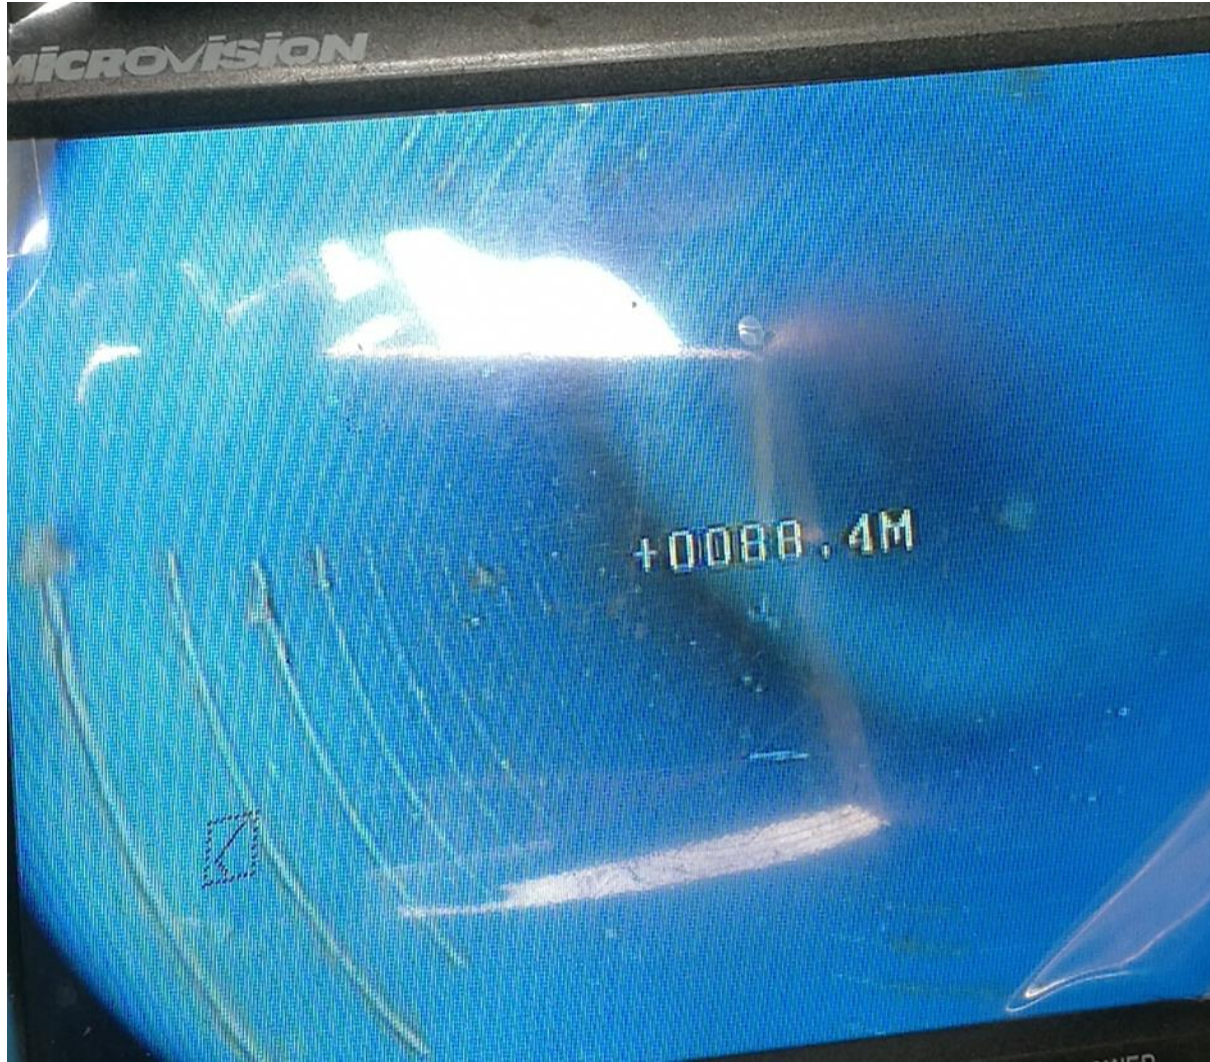
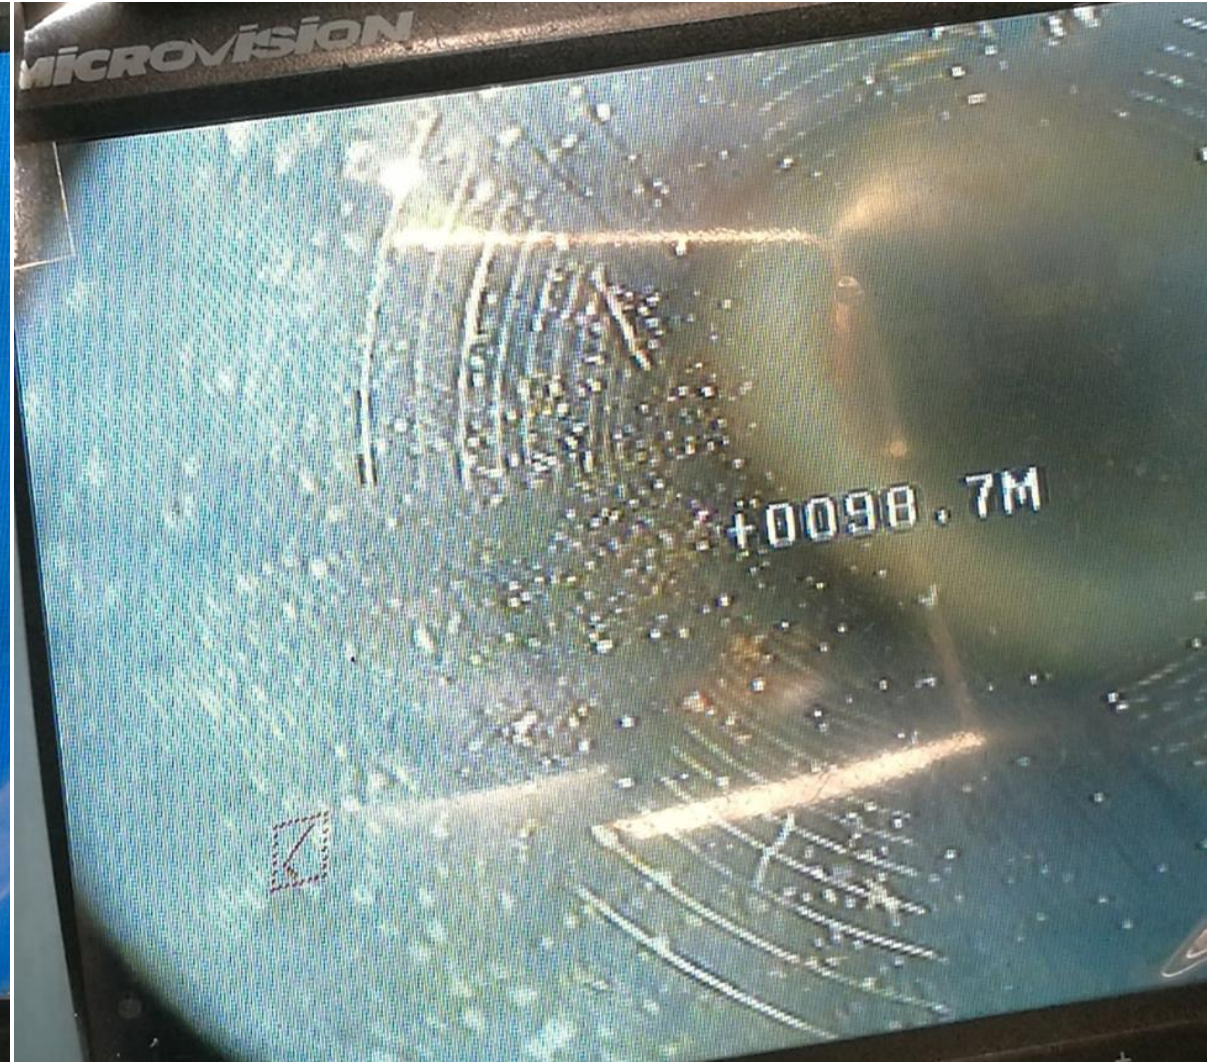
# STATUS OF SCREENS & CASINGS

- Confirm source of silting
- Clear screen can be seen

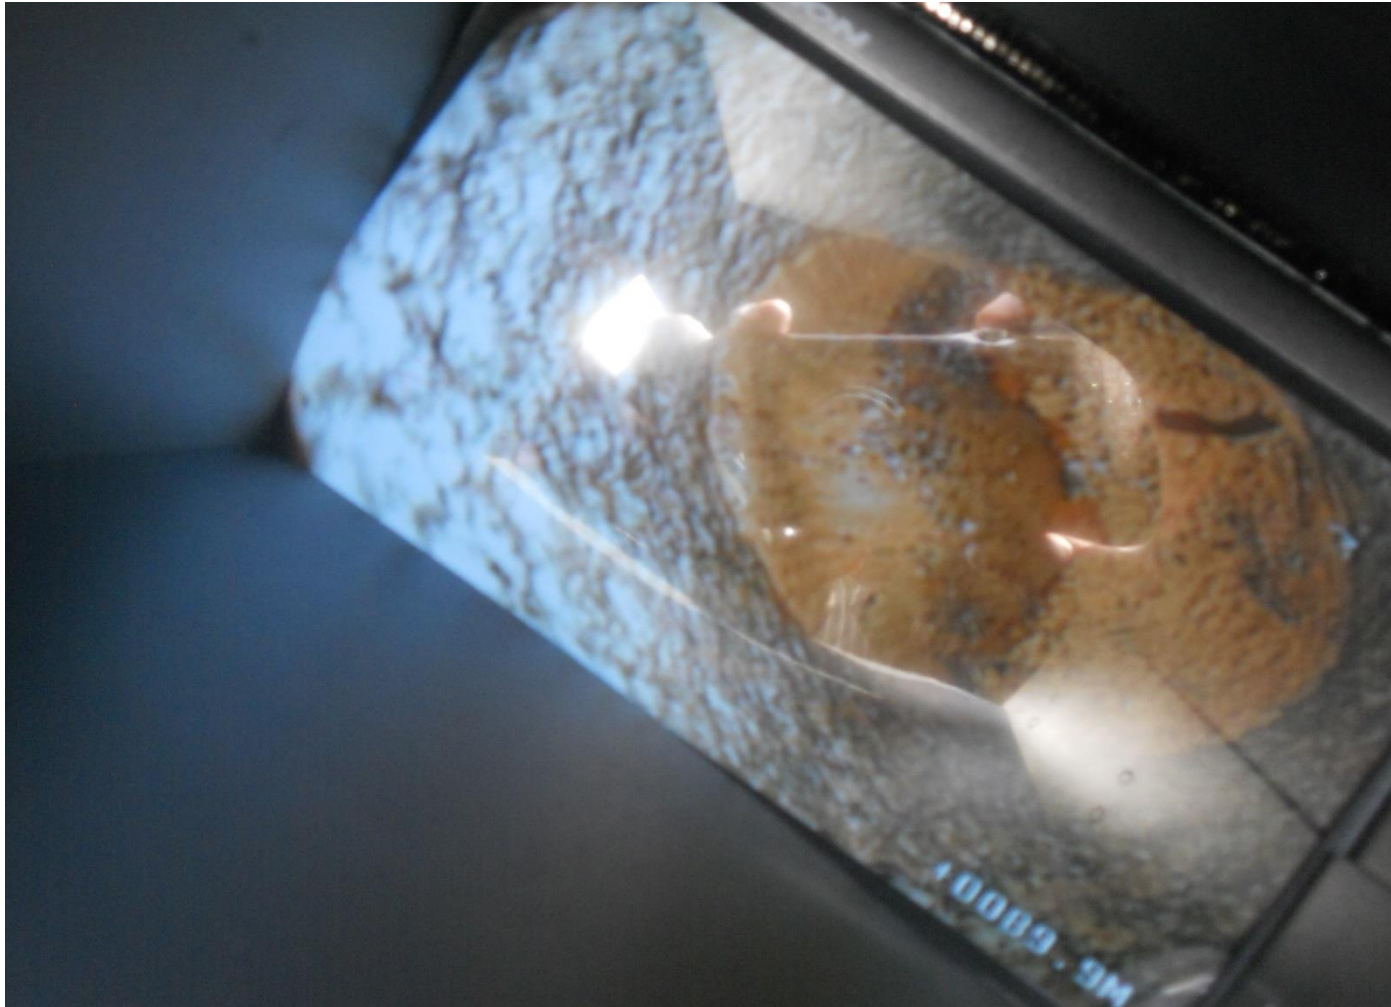
[Clip 1 The Well design](#)

# Level of silting in the wells

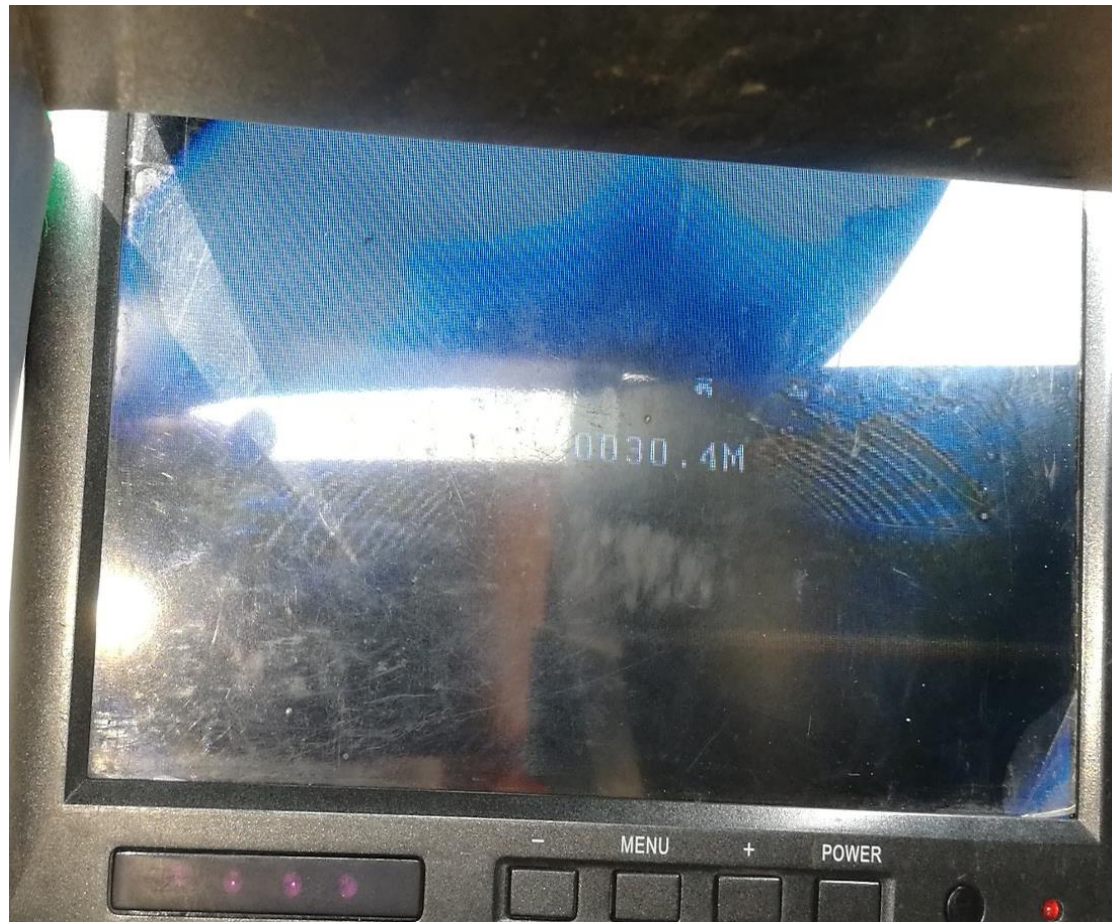
# REDUCING YIELD IN A BOREHOLE

SCREENS IN OVERBURDEN at  
**30.4m**

- There is need to adhere to the Ministry's directive of use of SS/UPVC pipes and SS rods materials for installation.
- The Ministry guideline of using “CONSULTANT – CONTRACTOR ARRANGEMENT” to drill boreholes must be enforced in all ground water related projects.

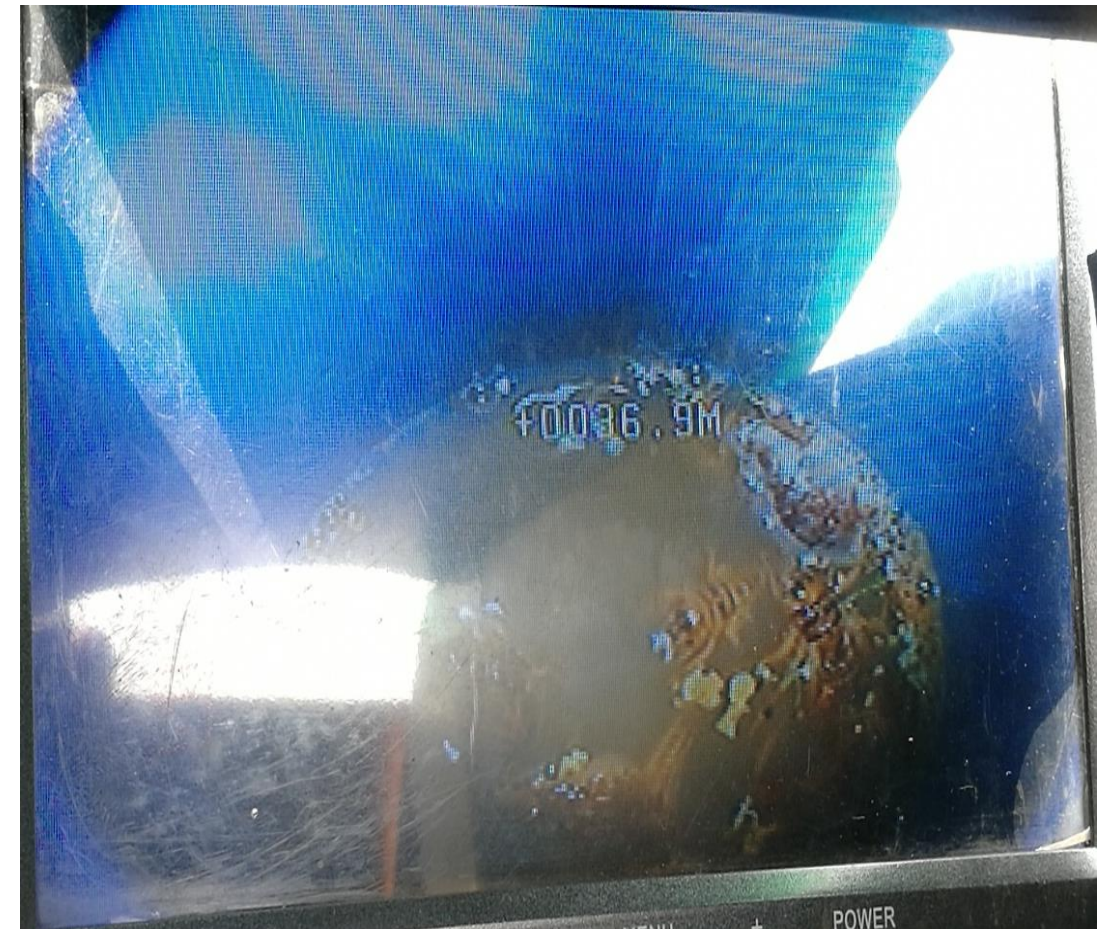
ACTUAL SWL OF WELL AT  
**36.90M**
